Upper Ninemile Creek Mine Reclamation and Sawpit Mine Reclamation

Site Photos Sawpit Creek

**Site Photos
Ninemile Creek**

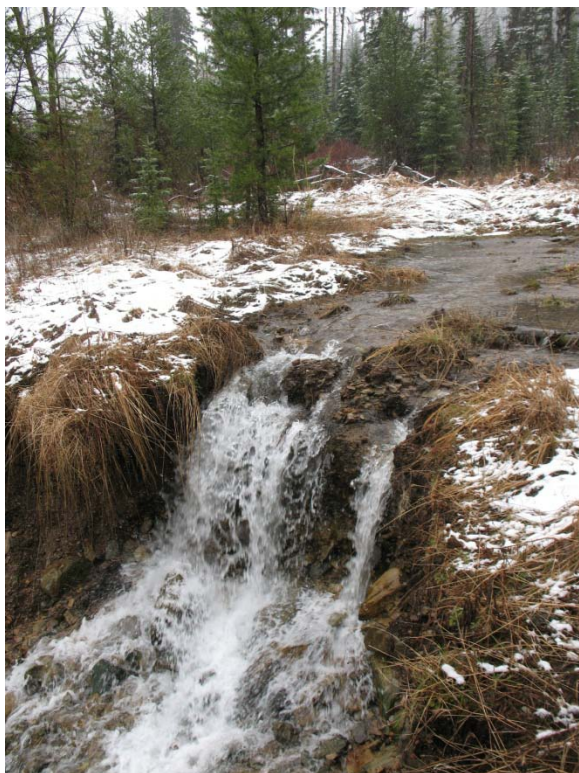
Headcutting and overland flow

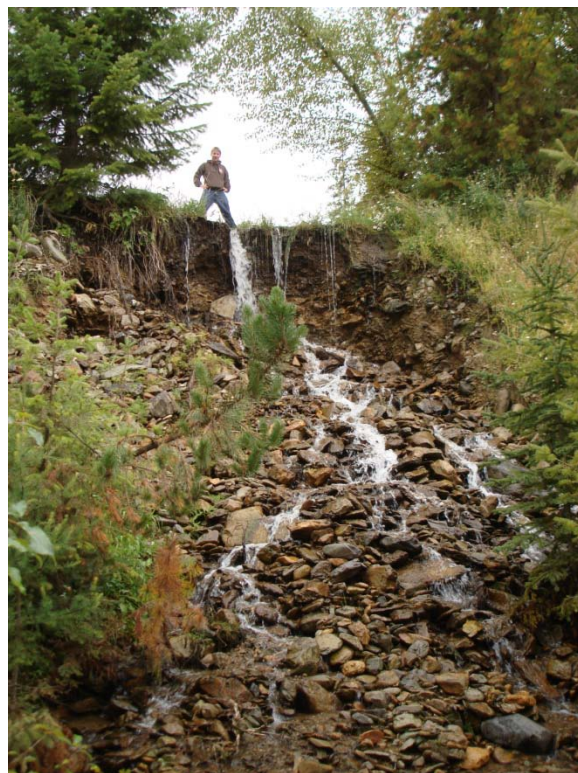
Steep bank into dredge pit

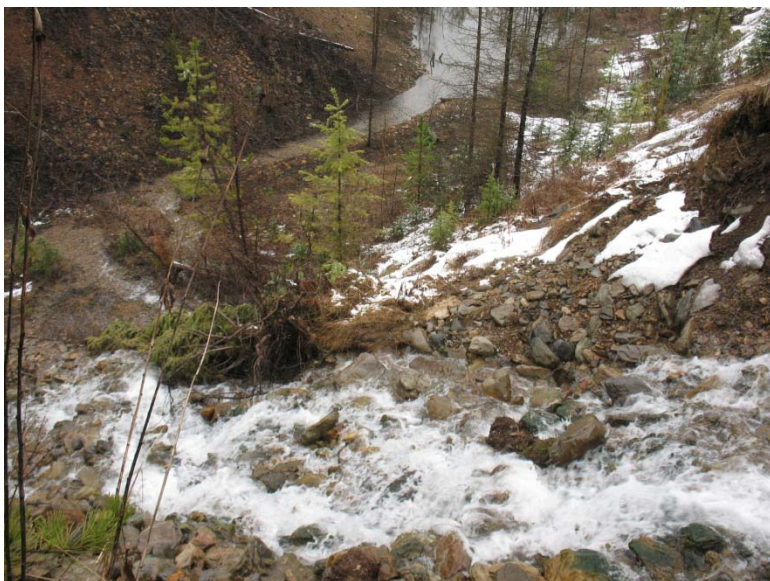
Gullying into dredge pit

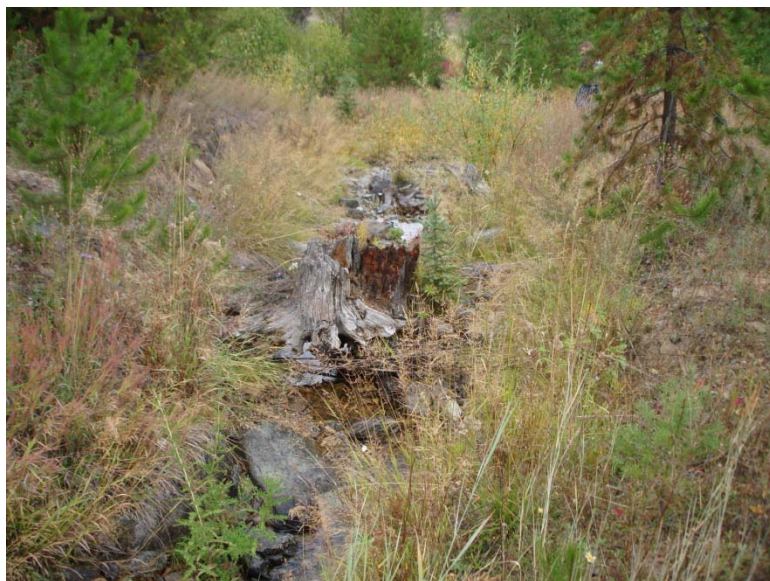
Sawpit Creek – existing conditions

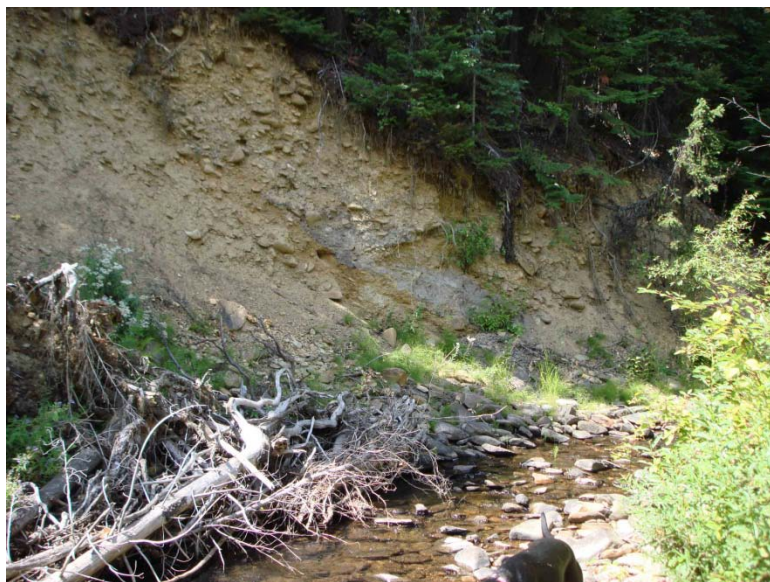
Steep eroding banks

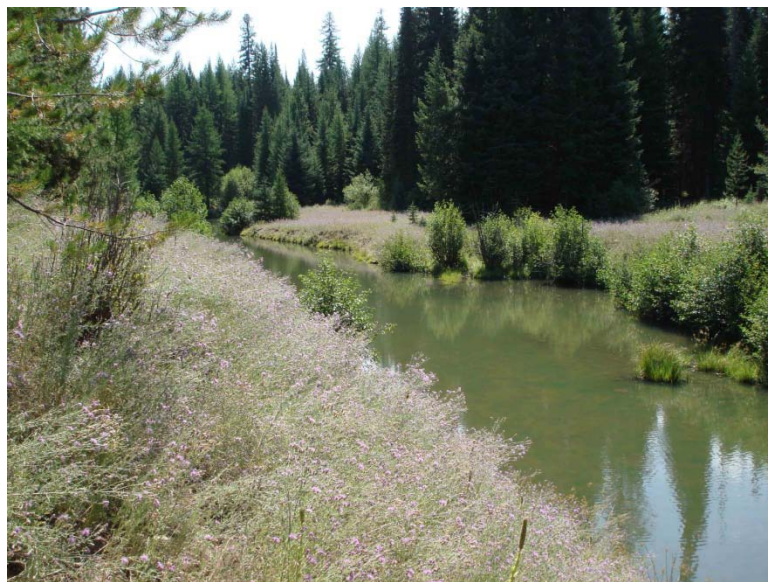
Dredge pond lined by knapweed

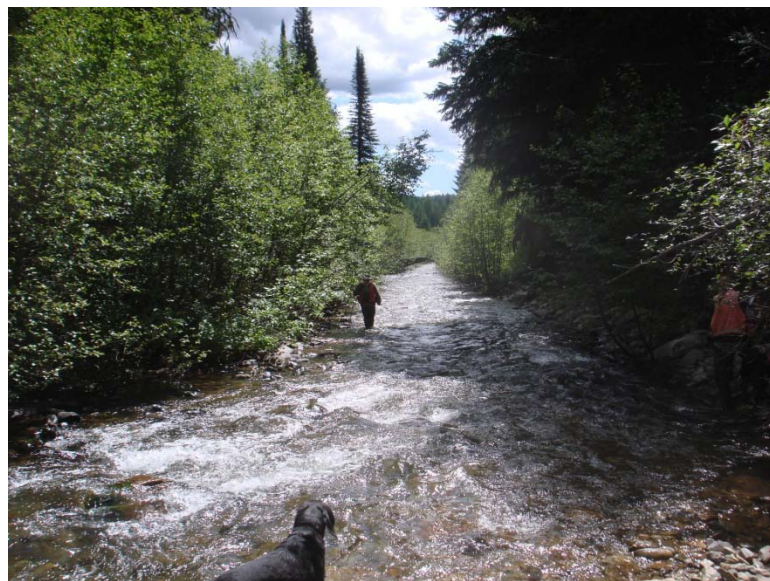
Straightened stream channel

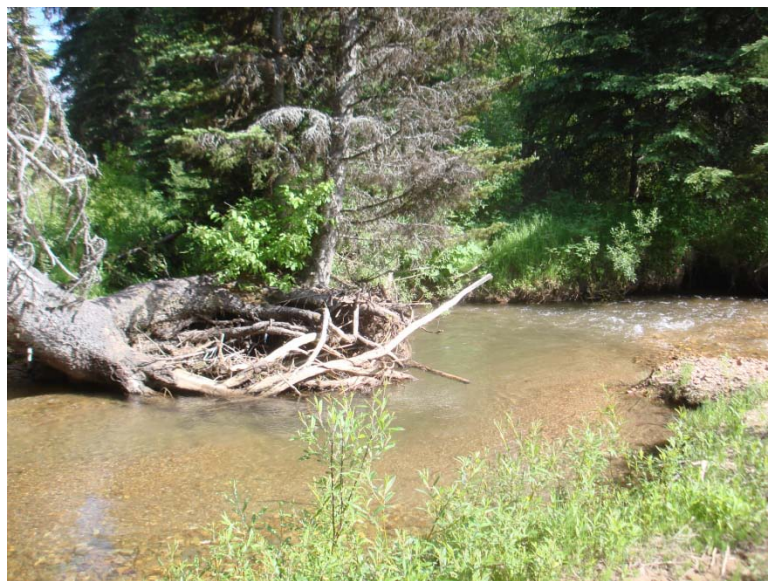
Reference conditions

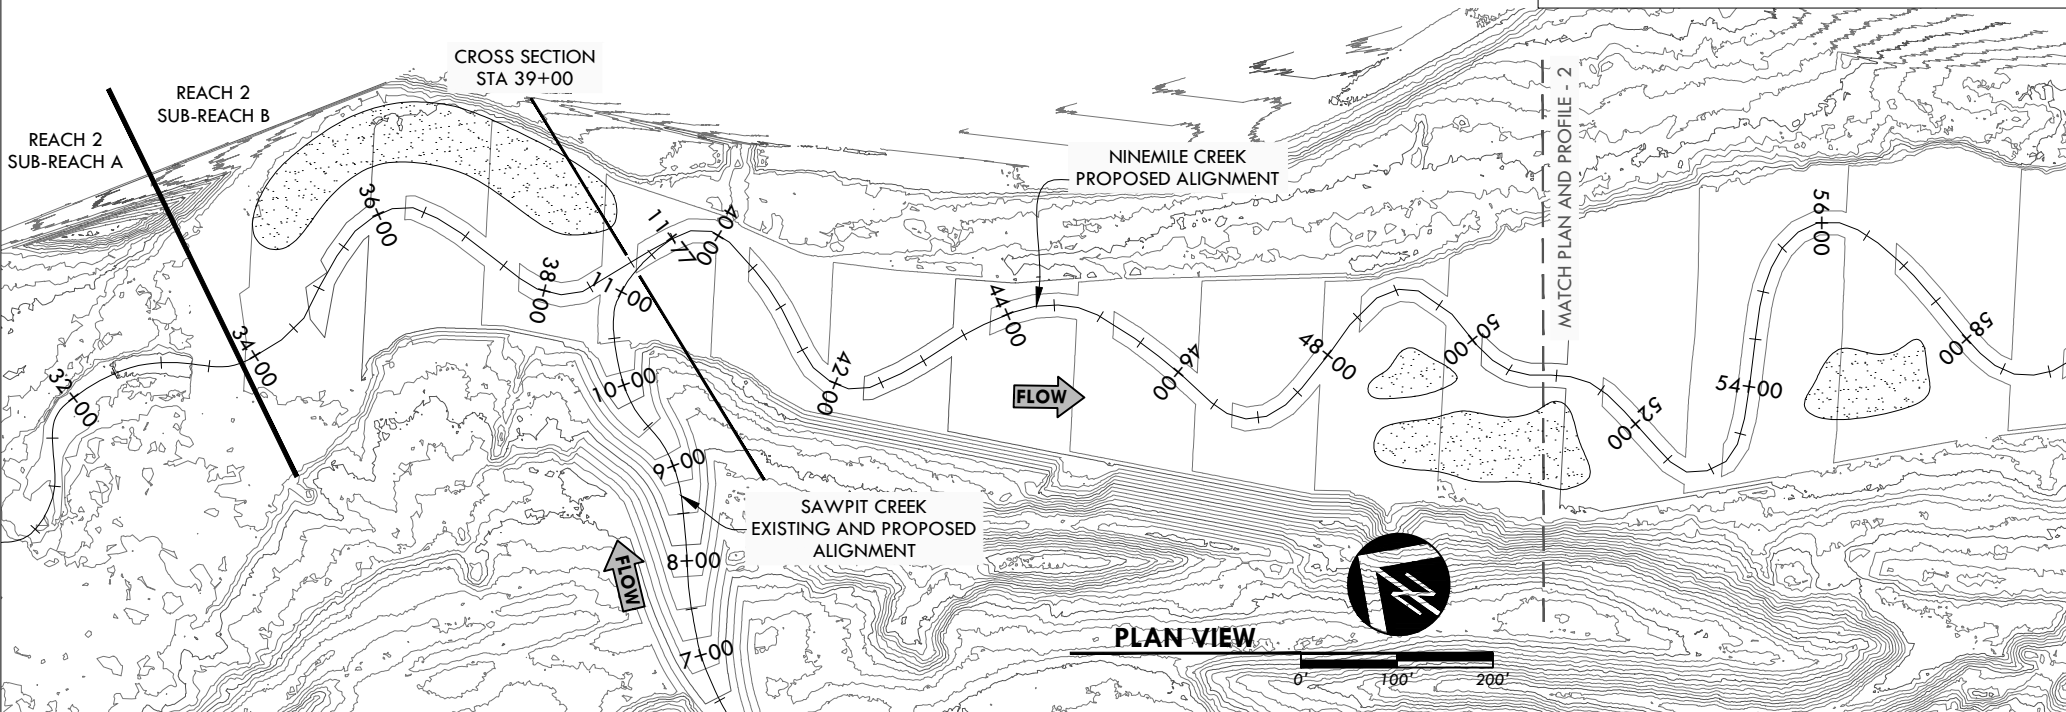
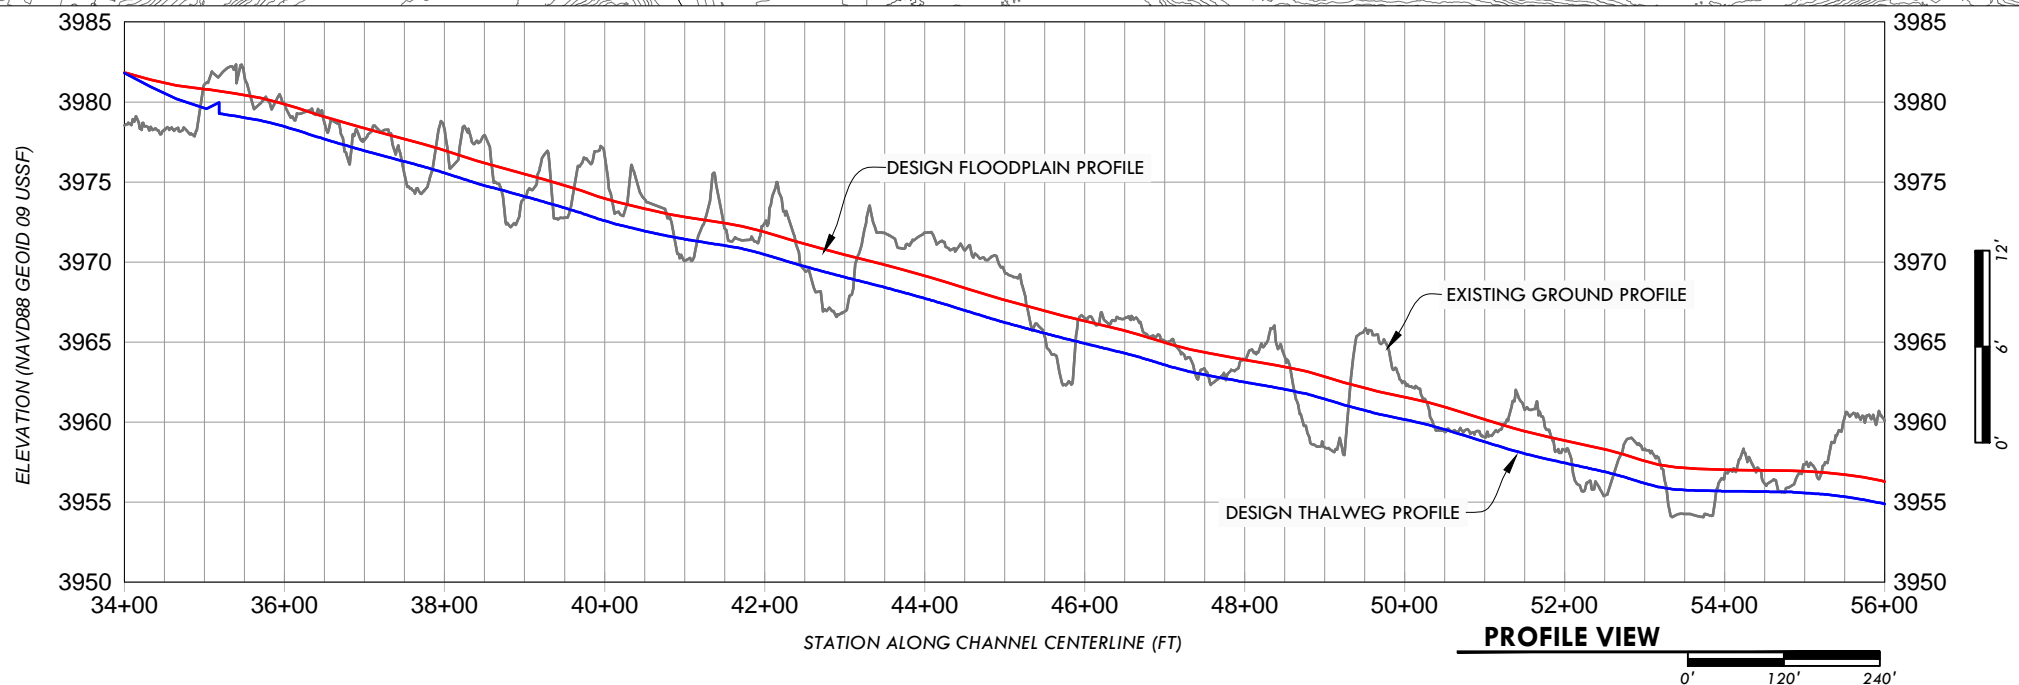
PLAN AND PROFILE - 1

PROPOSED OFF-CHANNEL WETLANDS

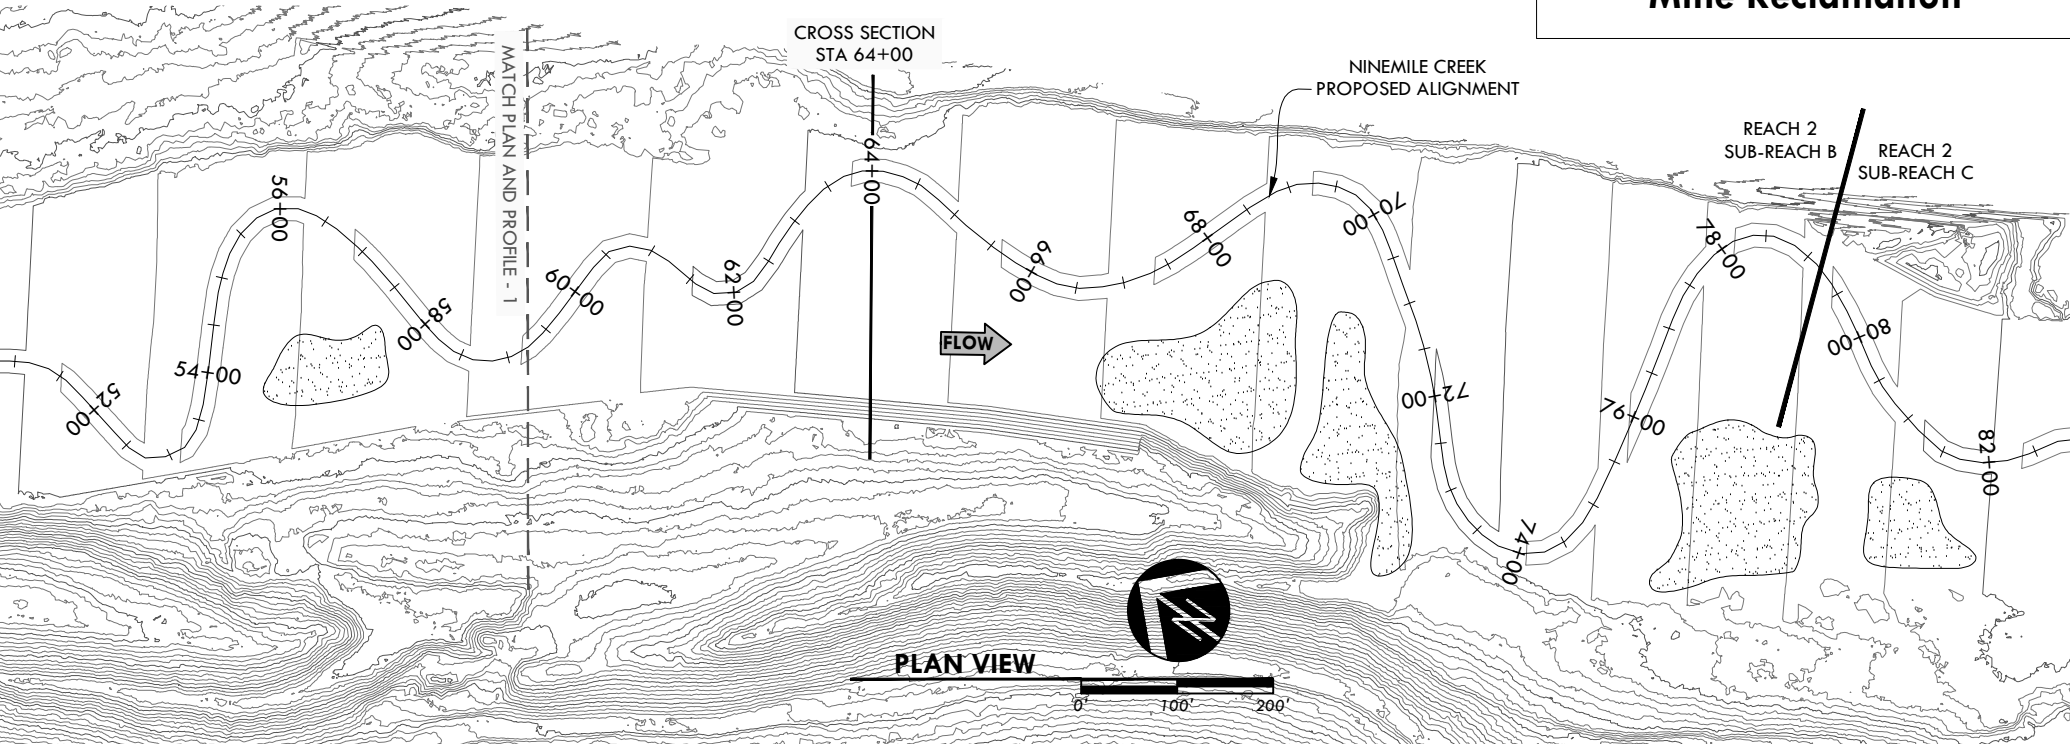
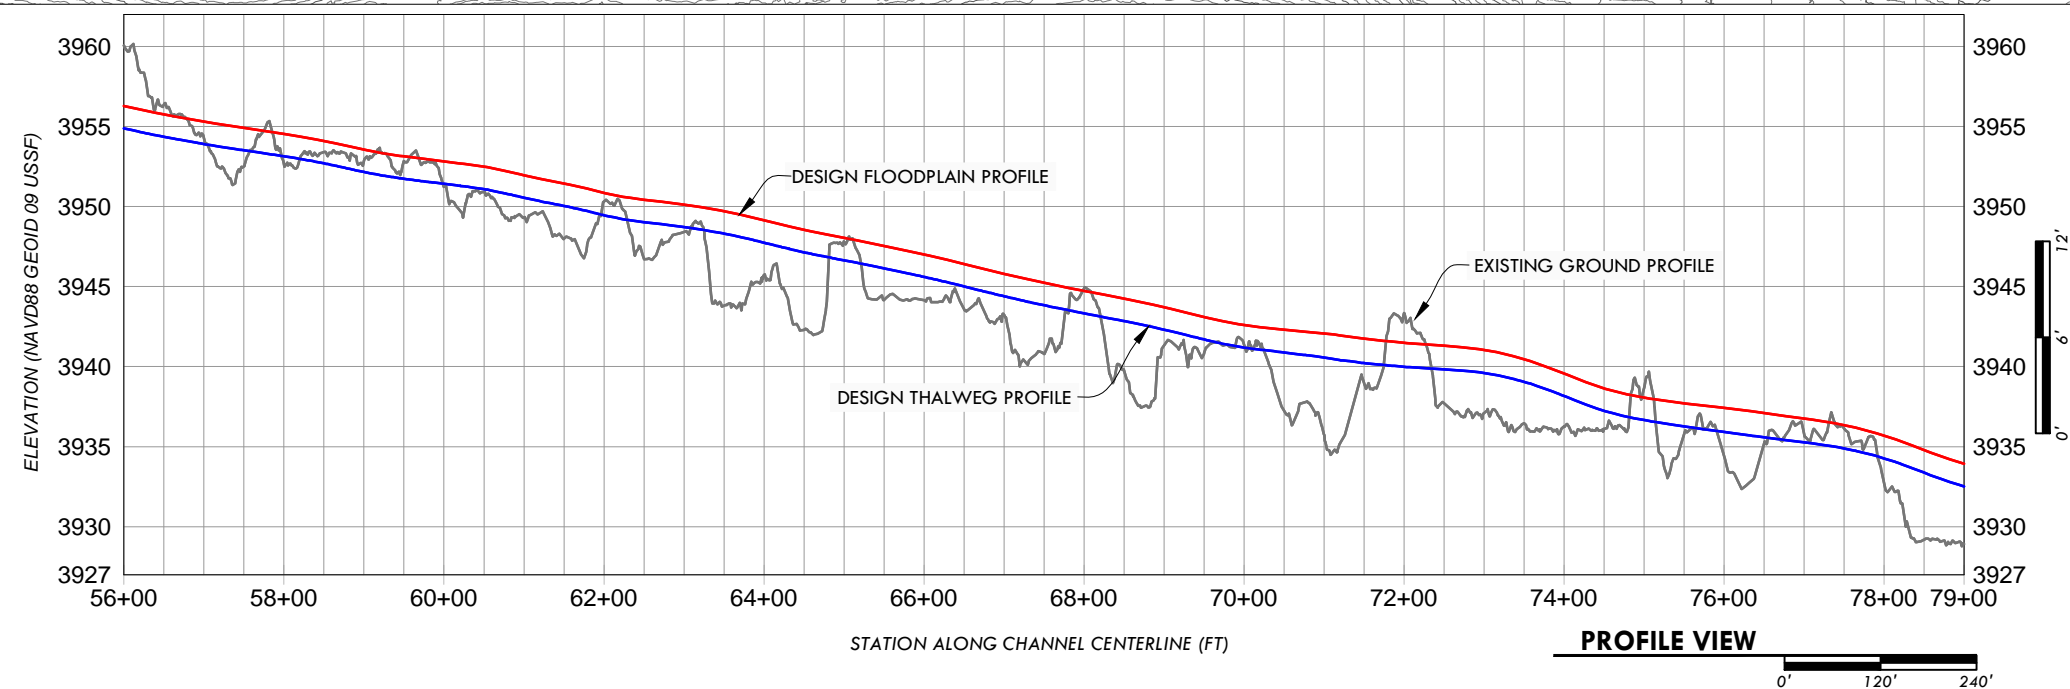
PLAN AND PROFILE - 2

Upper Ninemile Creek Mine Reclamation

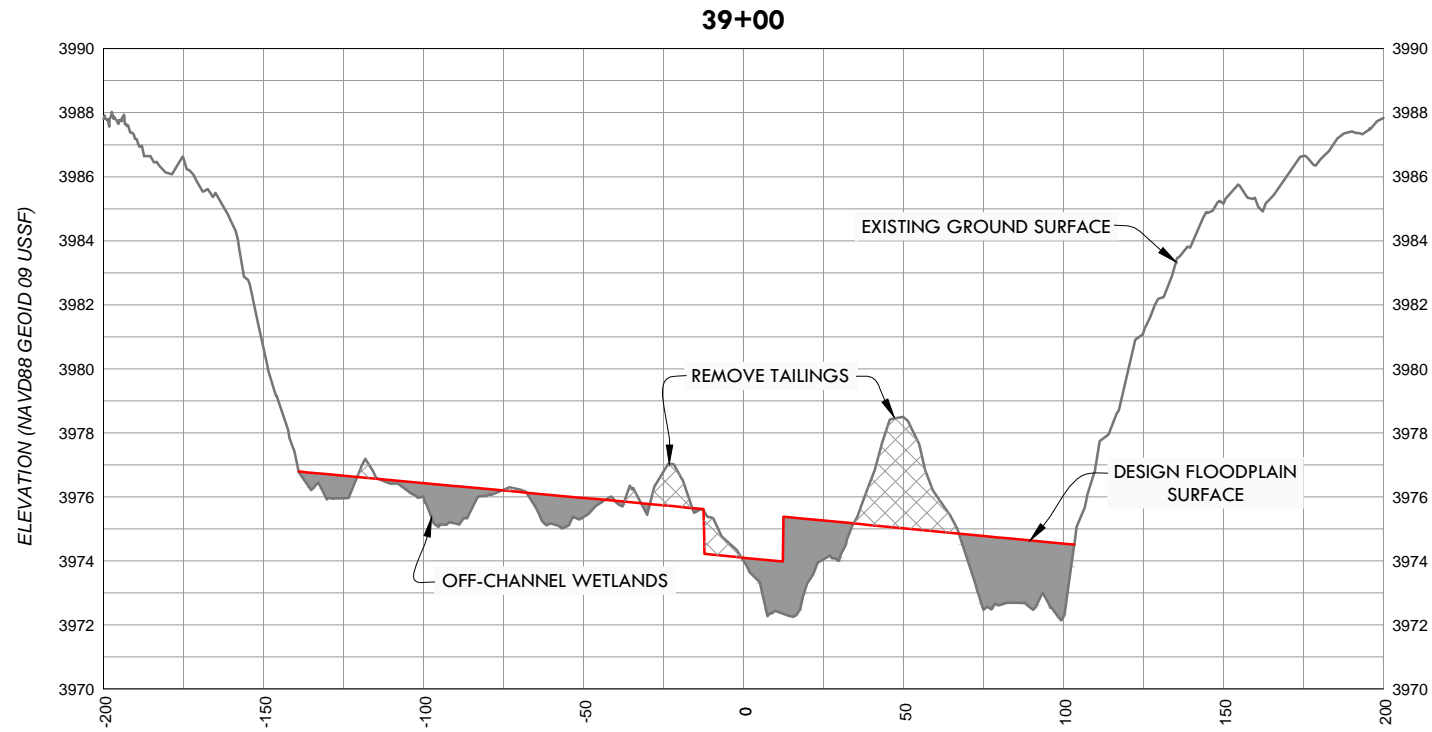
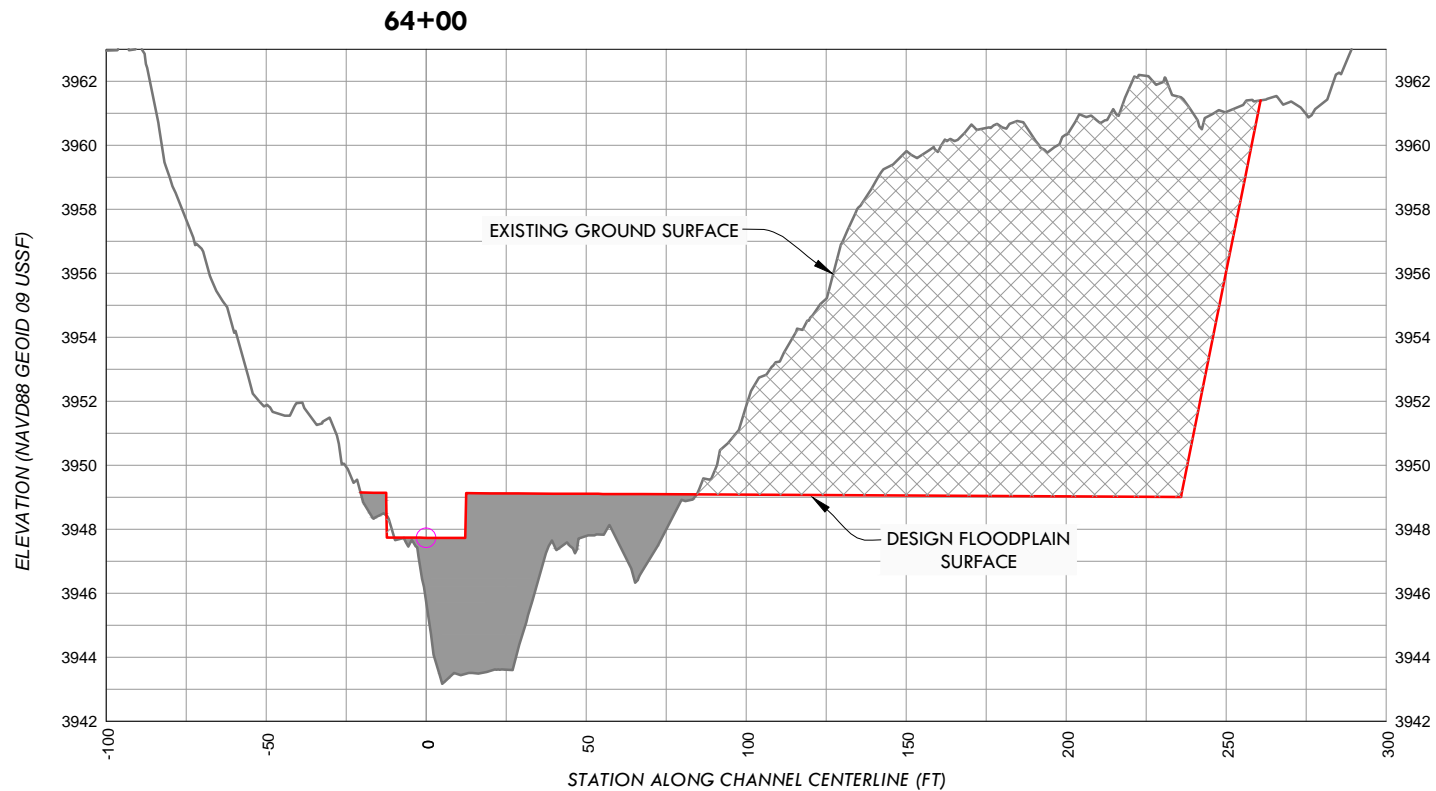
CROSS SECTIONS

Upper Ninemile Creek Mine Reclamation

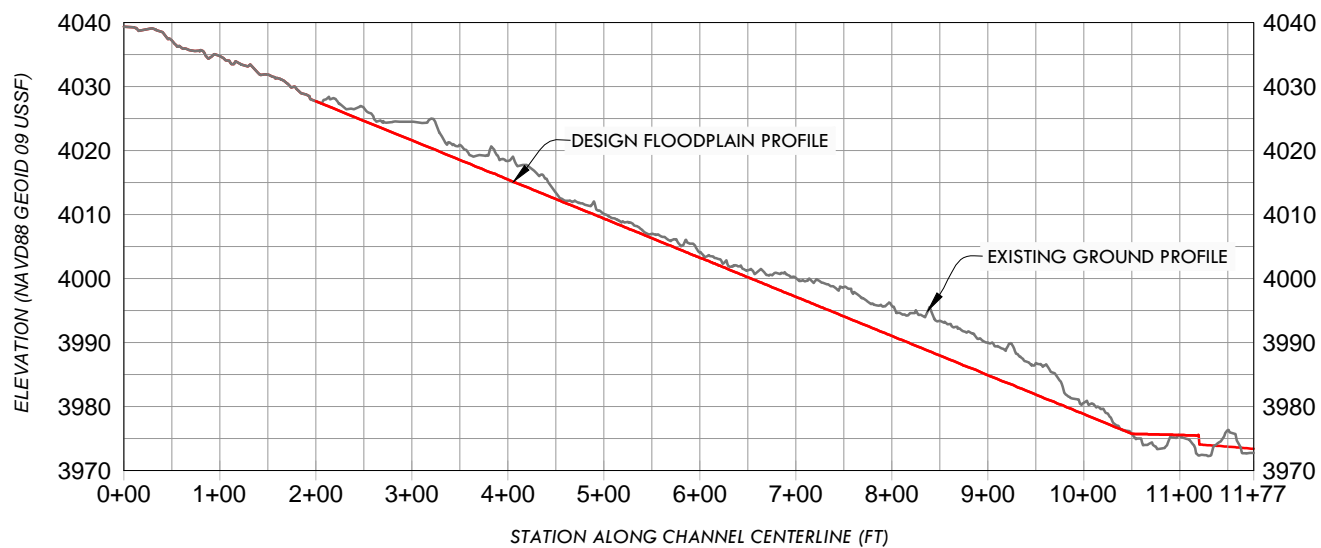
PLAN AND PROFILE - 3

Sawpit Creek Mine Reclamation

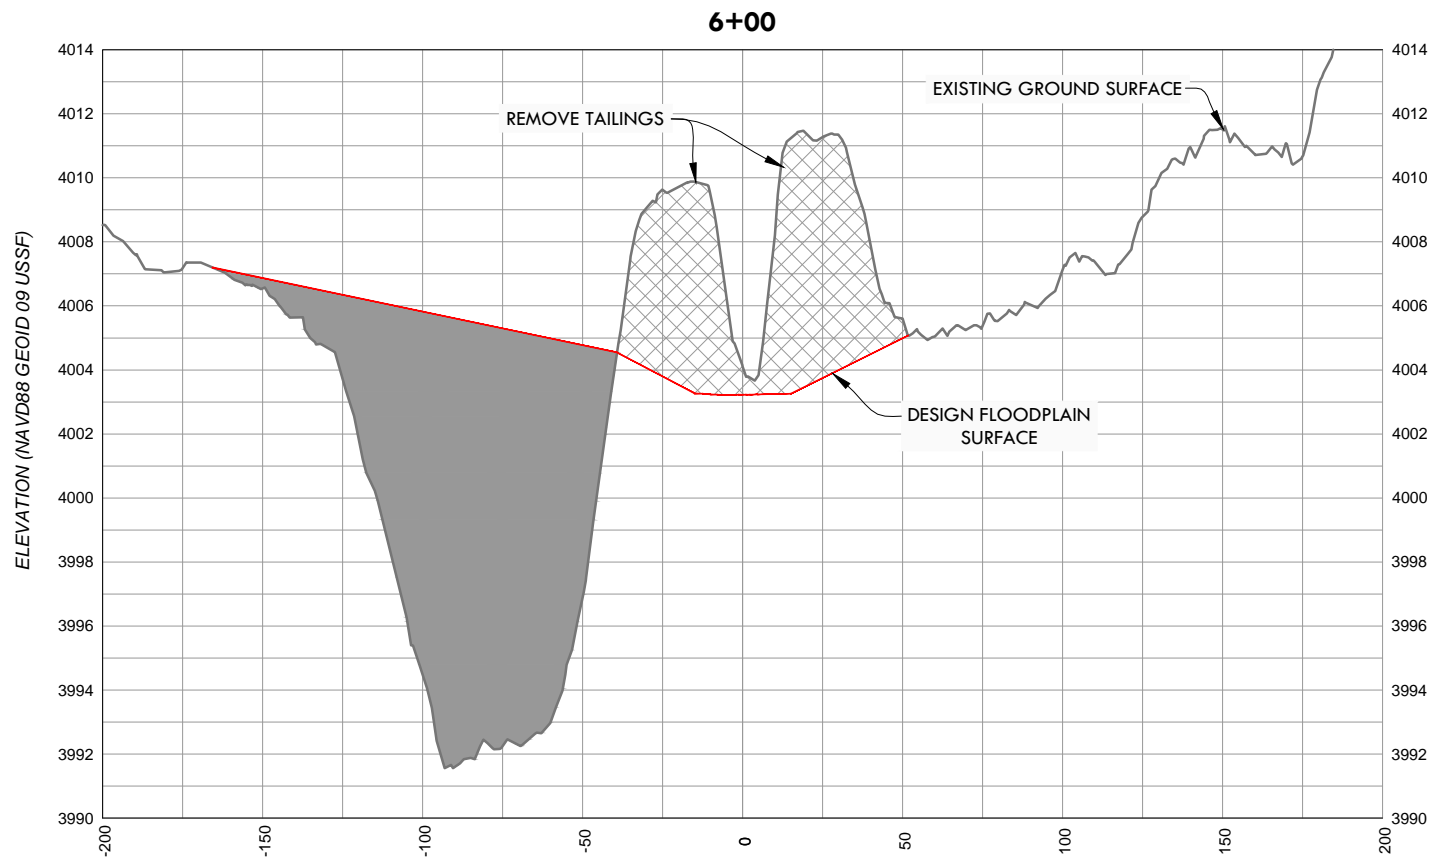
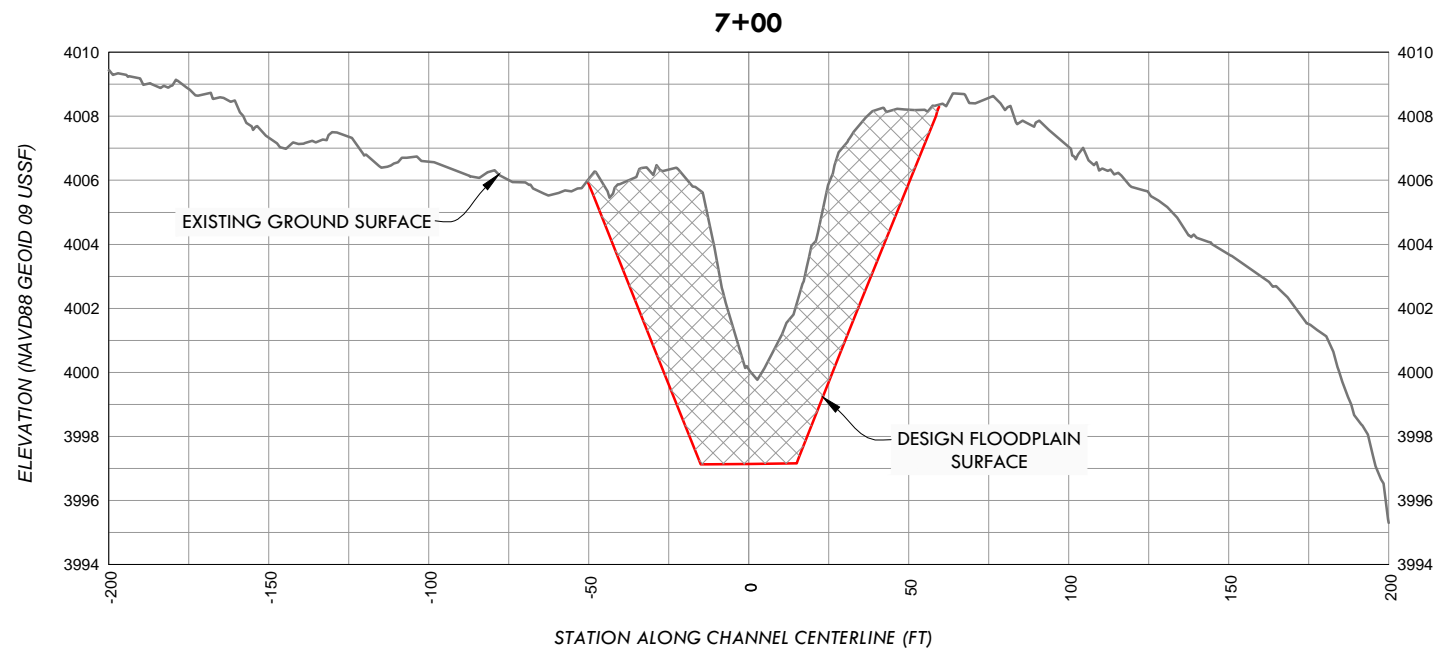
CROSS SECTIONS

Sawpit Creek Mine Reclamation
